Eastgate & St Michael's Conservation Area (Conservation Area No. 4)

Appraisal & Management Proposals

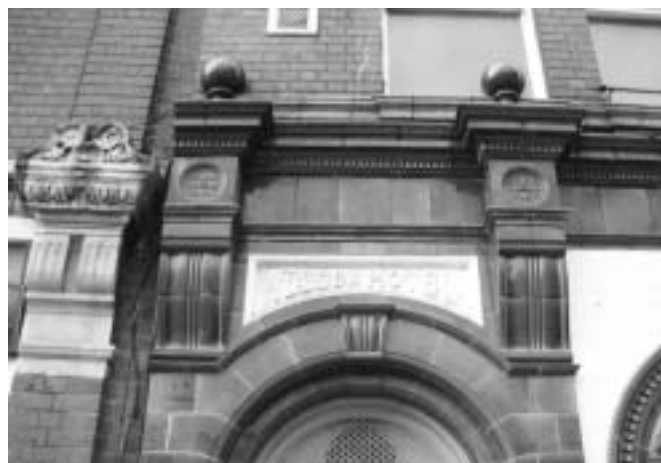
Detail of the glazed tiles at the former Wessex Hotel, Clarence Street frontage.

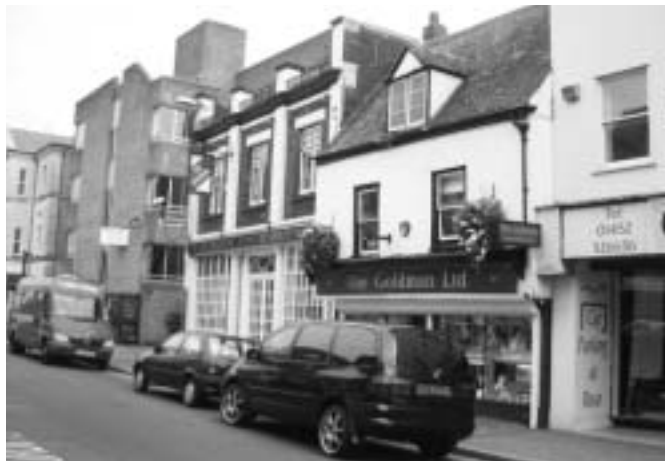
No. 87 Eastgate Street (*The Goldman Ltd*) dates from the late 16th century.

The majority of the area's listed buildings are located in Eastgate Street which was originally part of a linear medieval suburb. Two listed buildings, no 87 and no. 108, have partial timber frames which date from the late 16th/early 17th century, the oldest buildings in the conservation area.

Only a few pre-1750 buildings appear to survive in Eastgate Street. The most notable (nos 87 and 105) have timber-frames encased by a later brick/stucco frontage. Most buildings from the end of the 18th century onwards are built of red brick. Stone buildings are not common. Stucco, a form of render, can be found on the facades of many buildings from the 1830-1870 period.

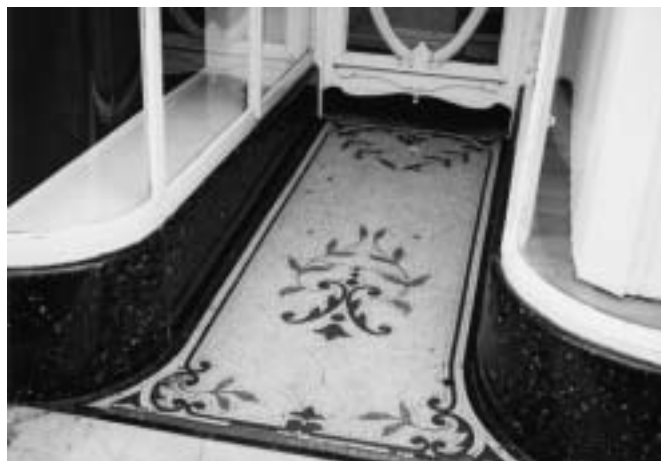
Decorative mosaic at nos. 84 and 86 Eastgate Street.

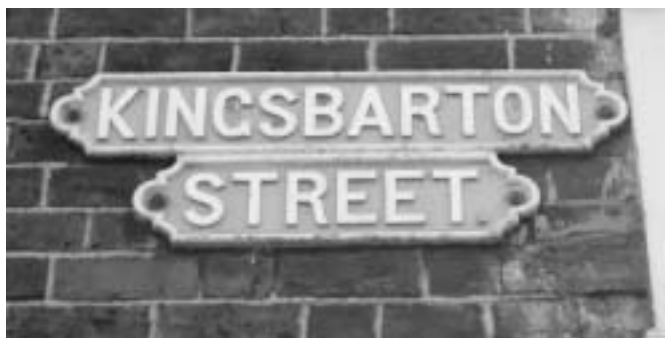
Characteristic iron street name sign.

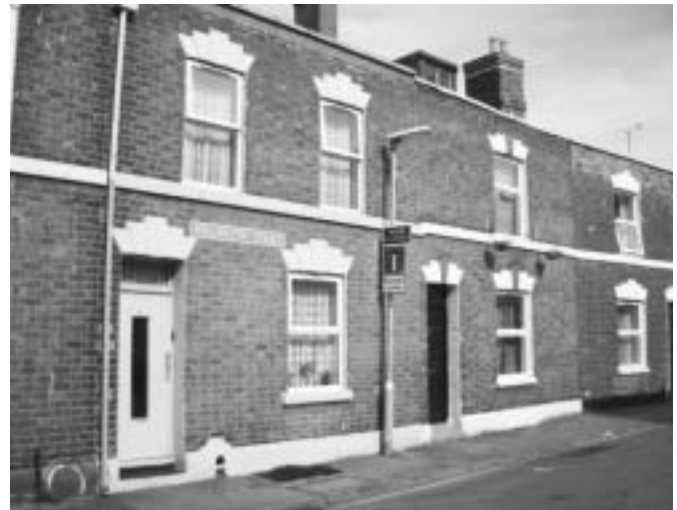
Two storey brick terrace in Wellington Street (west side).

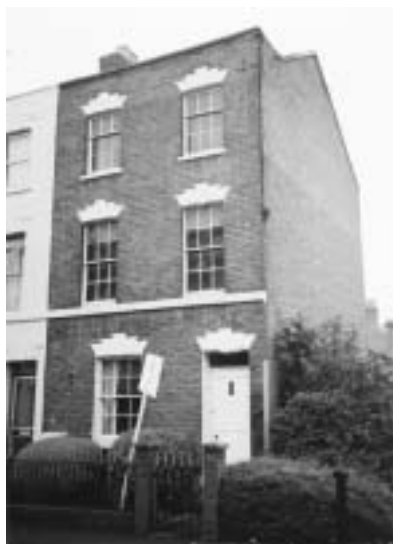
No. 21 Cromwell Street retains many original features.

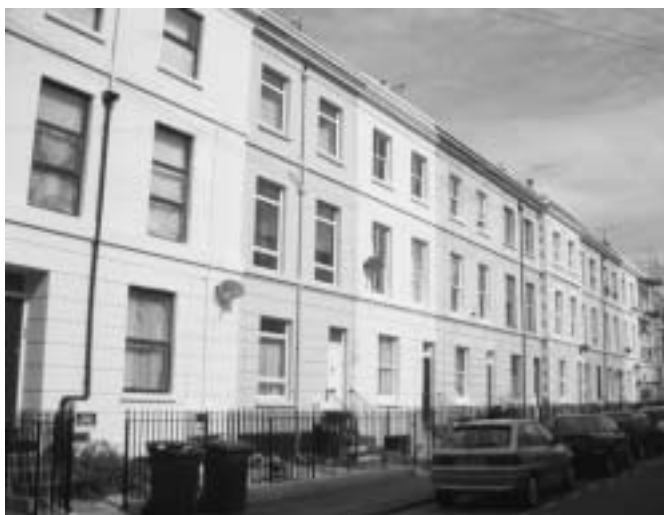
Three storey stucco terrace in Wellington Street (west side).

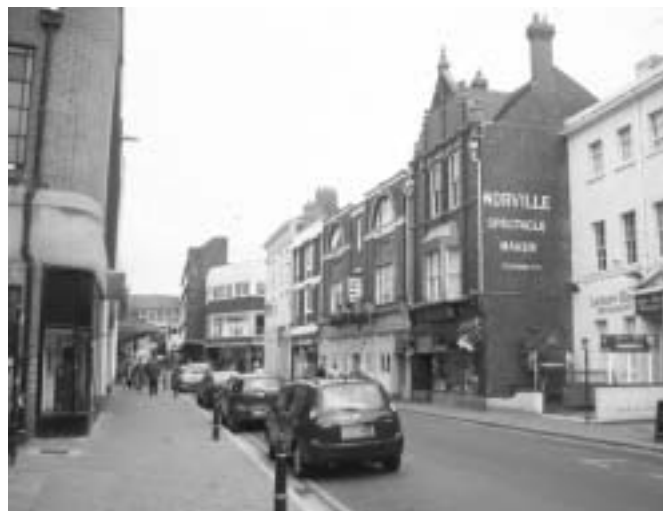
Nos. 82-92 Eastgate Street with remaining parts of historic shopfronts.

The conservation area contains a number of good examples of whole or partially altered historic shopfronts dating mainly from c1870-1910. These are listed in the conservation appraisal.

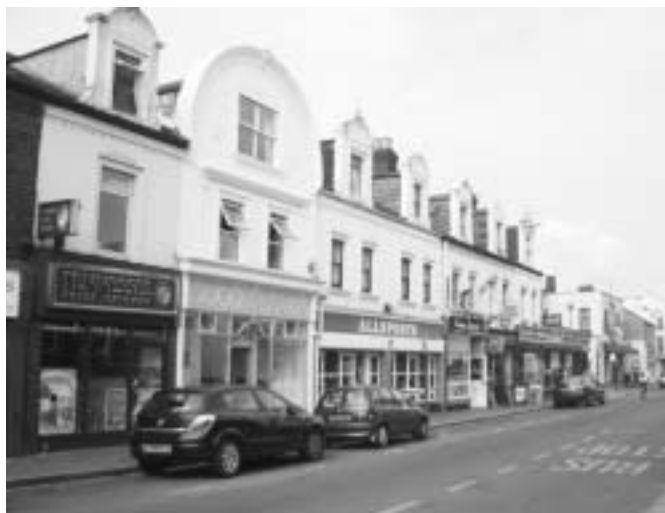
Nineteenth century parade of shops, nos. 120-130 Eastgate Street (south side).

Of note are: nos 120-130 Eastgate Street, a late 19th century row of shops with distinctive dormers; Wessex House, a four-storey brick and terracotta former hotel with green glazed tiled shopfront; nos 24-30 Russell Street (1863 by Jacques and Son); nos 8-16 (even) Arthur Street and nos 1-20 St Michael's Square.
